## Hurricane Ike Tree Mitigation Plan

BROADWAY BOULEVARD  
(State Highway 87)

Galveston, Texas

October 2008

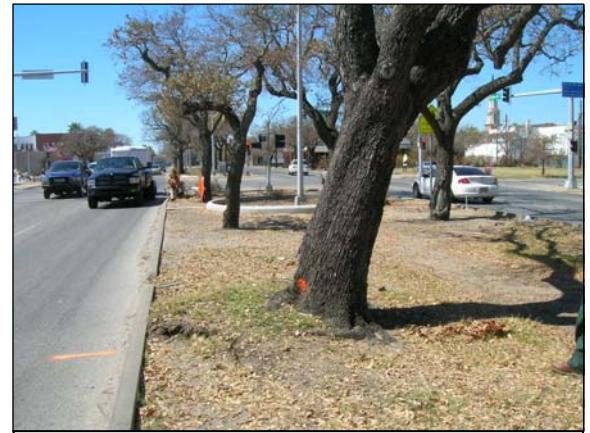
Live oak marked for removal due to root plate lifting

- Complete the removal of debris, stumps, and standing trees marked for removal.
- Broken limbs greater than 2" in diameter that pose risk to pedestrian or vehicular traffic should be located and removed as soon as possible.

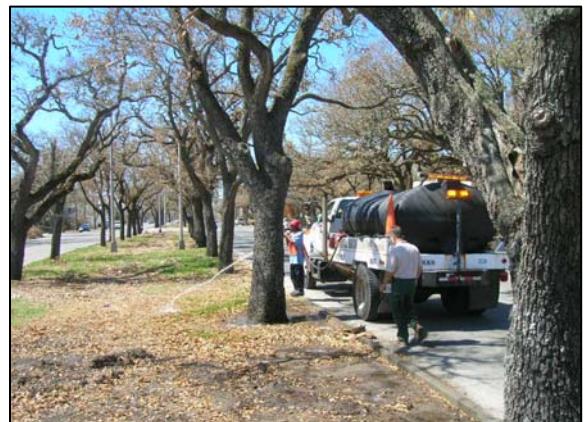
A more pressing problem, though, is that all of the oak trees are showing signs of salt damage, either from sea spray or the storm surge. High levels of sodium (chemical symbol Na) can interfere with water absorption and result in "burned" leaves, causing them to brown and fall off. In the weeks since the hurricane, some trees have begun to put on new leaves, which is a good sign. However, since salt levels may persist in the soil for some time, these new leaves may also burn and drop. If the trees cycle through just one or two flushes we believe most of the trees will survive; however, trees that cannot maintain a healthy crown of leaves because of high soil salt levels will spiral into decline and, possibly, death.

City crews watering trees to leach salt from the soil

- Watering will help leach salt levels out of the soil. All trees should receive 8 to 10 gallons per diameter-inch at least once a week as long as rainfall is less than 1-inch per week. This program should continue into mid-winter 2009.

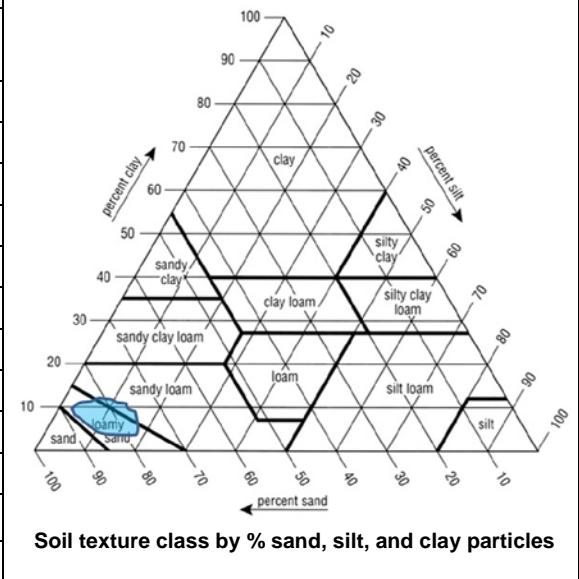
Second, all the medians have very sandy soil texture, as shown in the shaded area of the soil texture triangle. This makes leaching of the salts feasible with watering alone. On clay soils, gypsum is sometimes added to chemically release the sodium ions into solution so that watering will wash them away.
