1148 COMPLEX FIRE

PALO PINTO COUNTY

APRIL 9, 2009

A CASE STUDY

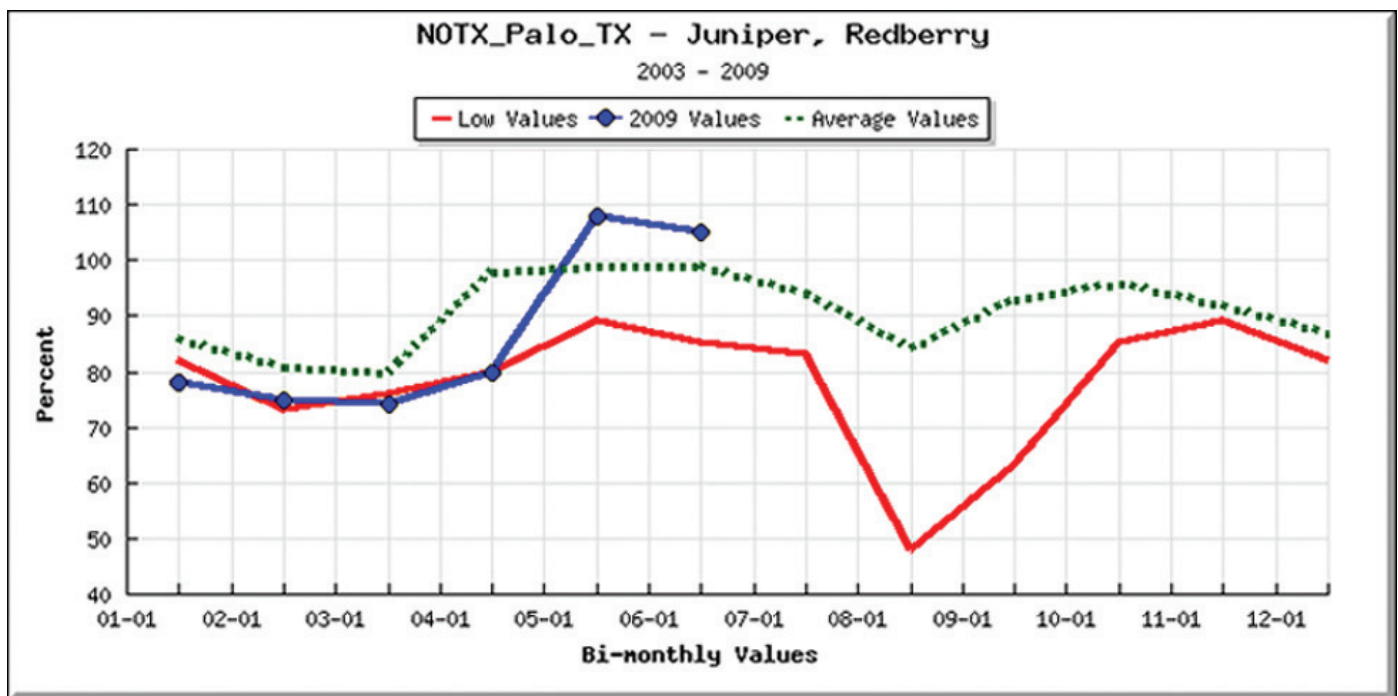
Live plants can either suppress combustion or contribute to it, depending on their moisture content and flammability of chemical compounds contained in the plants. Successive years of drought may be sufficient to cause mortality in juniper. The North Texas Predictive Service Area (PSA) is an area where the weather reporting stations, or a group of Remote Automated Weather Stations (RAWS), tend to react similarly to daily weather regimes and exhibit similar fluctuations in the fire danger and climate. During the first three months of 2009, reports from the North Texas PSA showed juniper levels in the 70s. This level put juniper live fuel moisture levels in the 97 percent percentile for critical fire behavior.

15-Jan	15-Feb	15-Mar	15-Apr	15-May	15-Jun	15-Jul	15-Aug	15-Sept	15-Oct	15-Nov	15-Dec
2009	78	75	74	80	108	105	-	-	-	-	-	-
Avg	86	81	80	98	99	99	94	84	93	96	92	87
Low	82	73	76	80	89	85	83	48	63	85	89	82

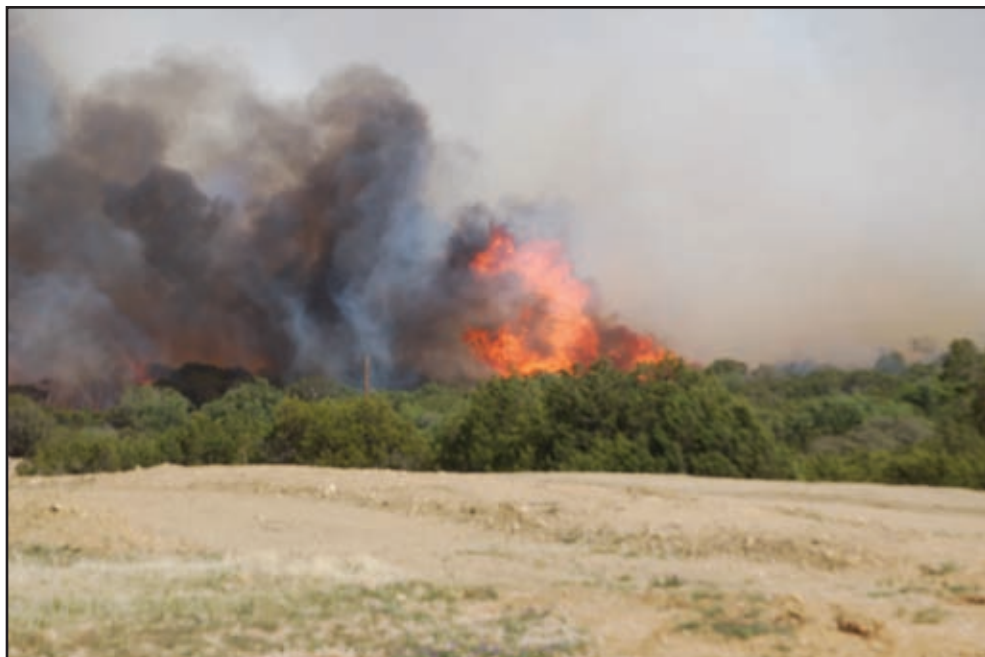
Extreme fire danger was forecast for Palo Pinto County. This designation meant that fires would start quickly, spread furiously and burn intensely. All fires throughout the region would be potentially serious. Fires that develop in conifer stands could be unmanageable while the extreme burning conditions last. The fire behavior on April 9 exhibited all the expected definitions and ratings.

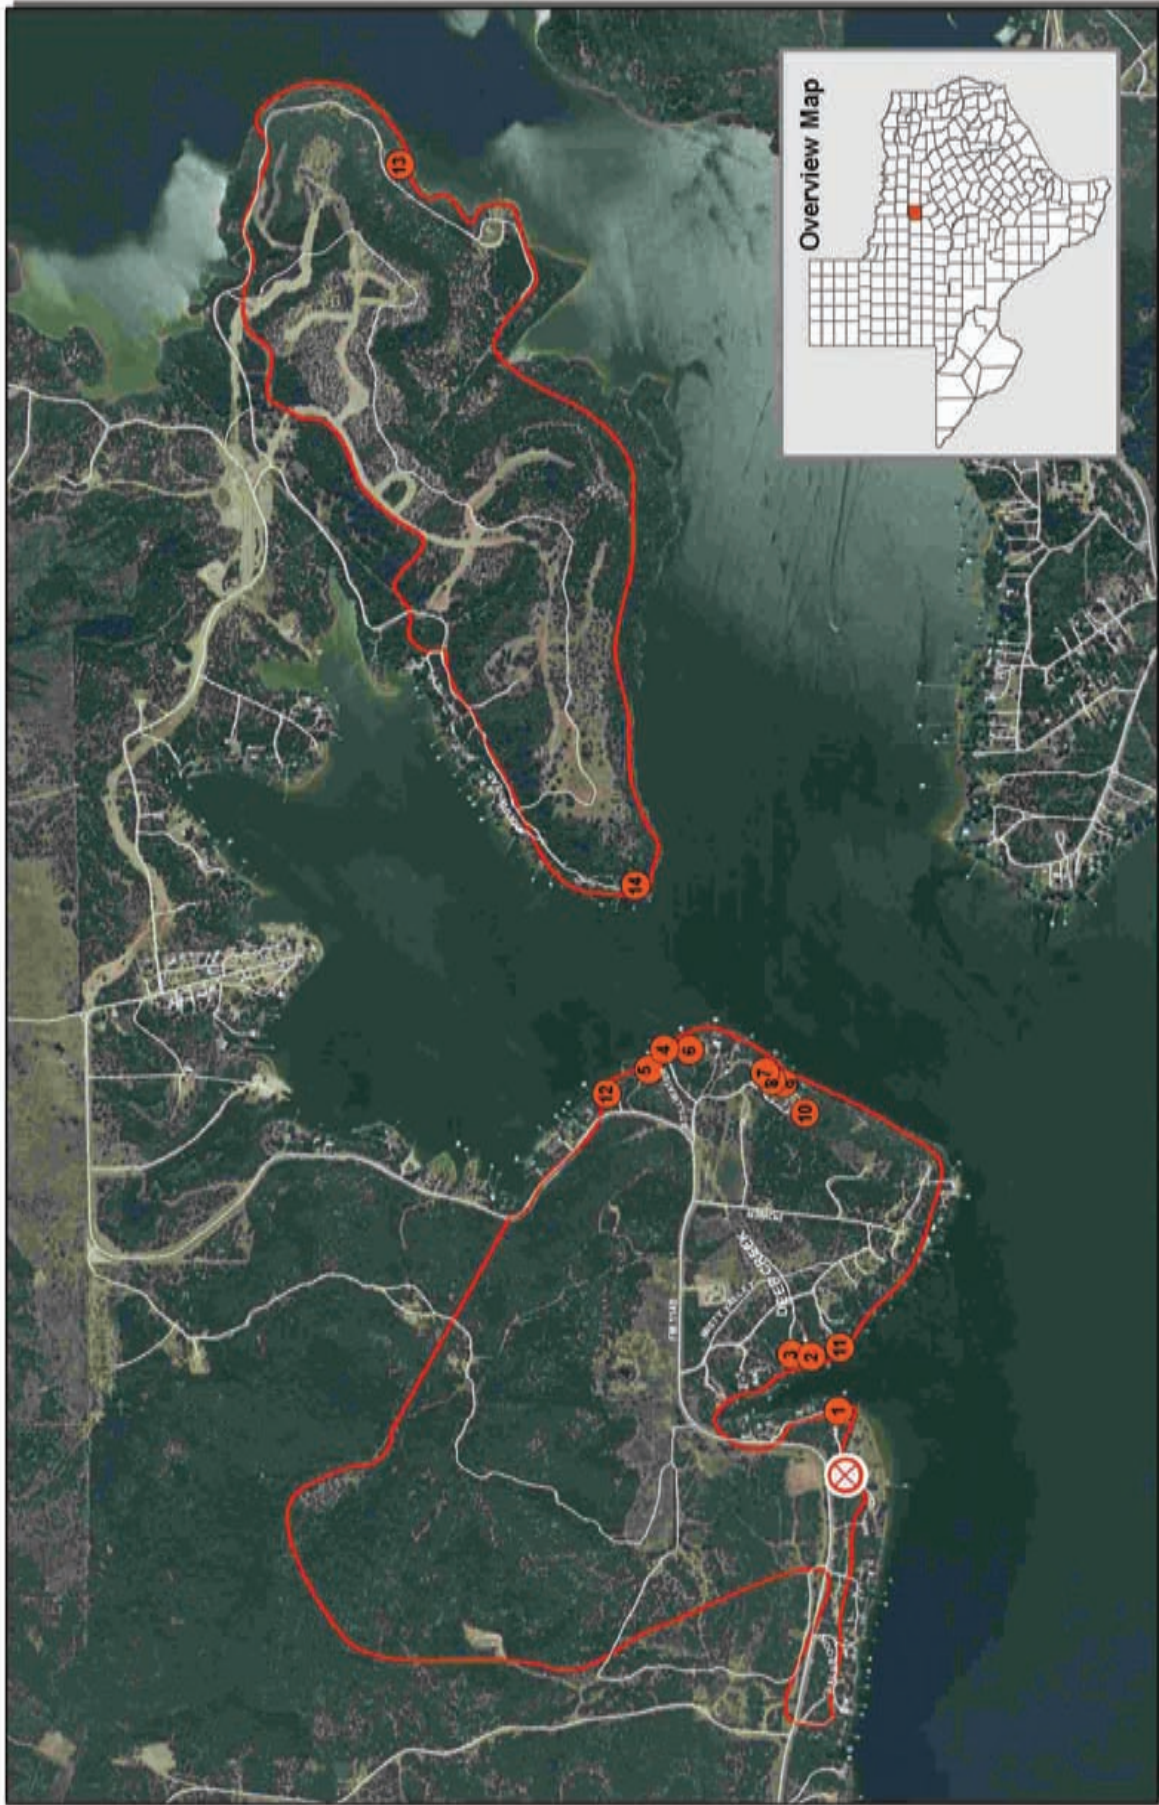
Home Losses and Fire Perimeter

FM1148 Wildfire - Palo Pinto County, Texas

● Lost Homes
 ⊗ Fire Origin
 □ Fire Perimeter

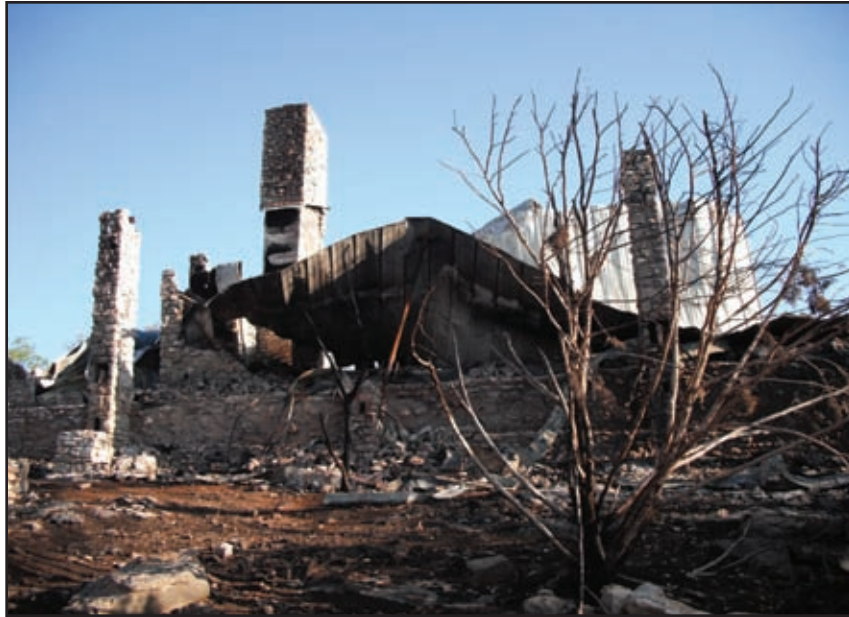
The first home lost was on Stringer Lane, near the ignition point of the fire. The fire progressed eastwardly through thick cedar and oak closed canopy with heavy dormant greenbrier (*Smilax bona-nox*) understory to the large rock and wood siding home. A large wooden deck with large oaks incorporated in the construction, ignited and exposed the home to intense heat. The fire burned down the slope to the shoreline. Cedar fence posts and wooden decking furniture served as additional fuel sources for embers and eventually the fire itself.

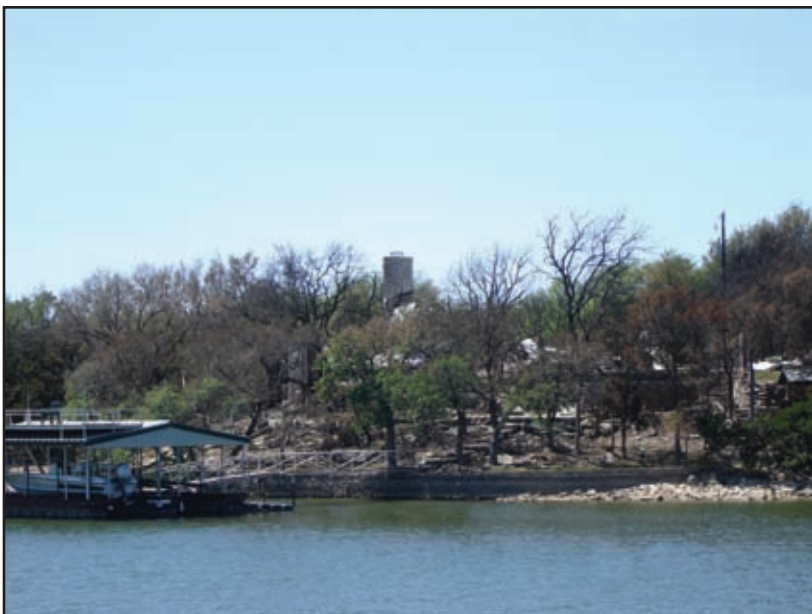
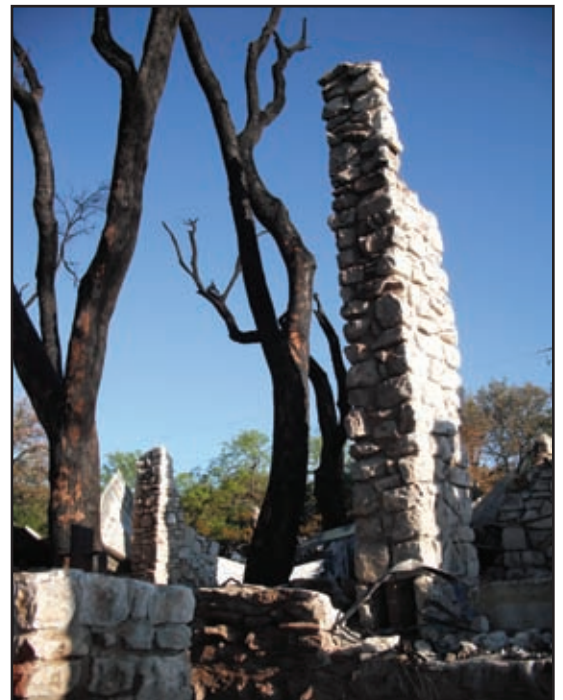
As the fire continued to burn northwardly through undeveloped areas, embers traveled across the 500-foot cove and ignited two mobile homes located on the adjacent side, 150 feet apart. Heavy ember production was seen raining down on the two-foot wide wooden docks, vegetation and homes. Wooden decks and vegetation proximity were documented as ignition sources around many homes.

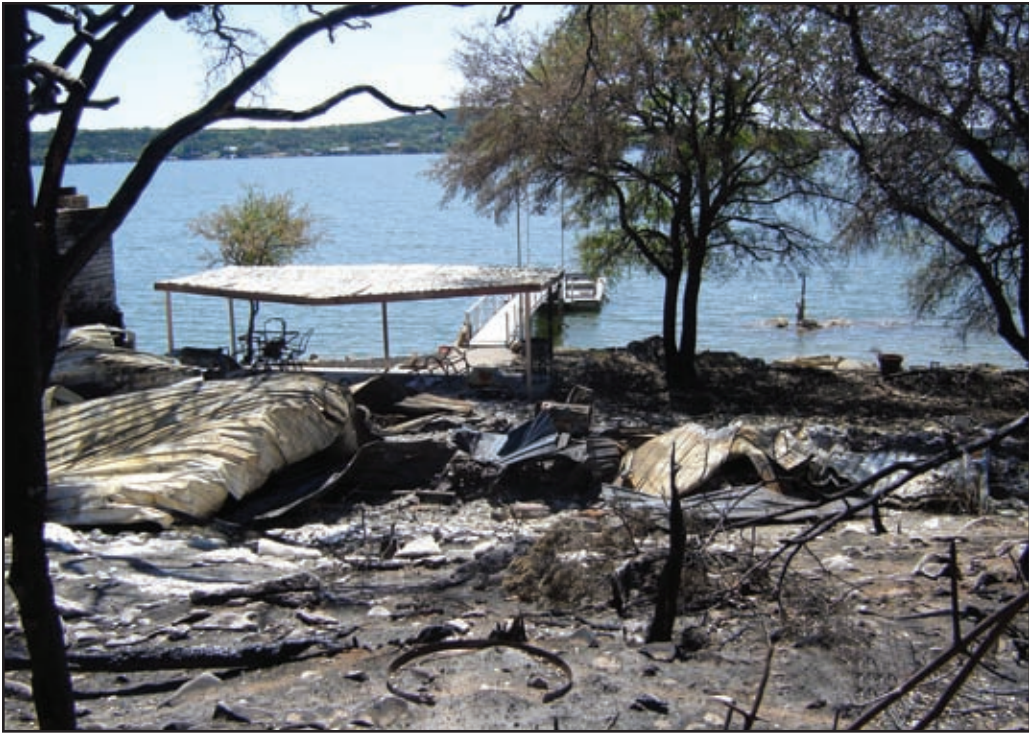
Another mobile home, this one located 300 feet south of the two neighboring mobile homes, was lost as the fire traveled eastward toward the opposite side of the inlet. The home was located at the bottom of the slope near the shoreline. Oaks with a heavy cedar understory surrounded the north, east and west sides of the home. Proximity to vegetation and leaf litter were contributing factors to the home ignition. Melted plastic lawn furniture sitting on a concrete pad next to the driveway provided more evidence of ember production.

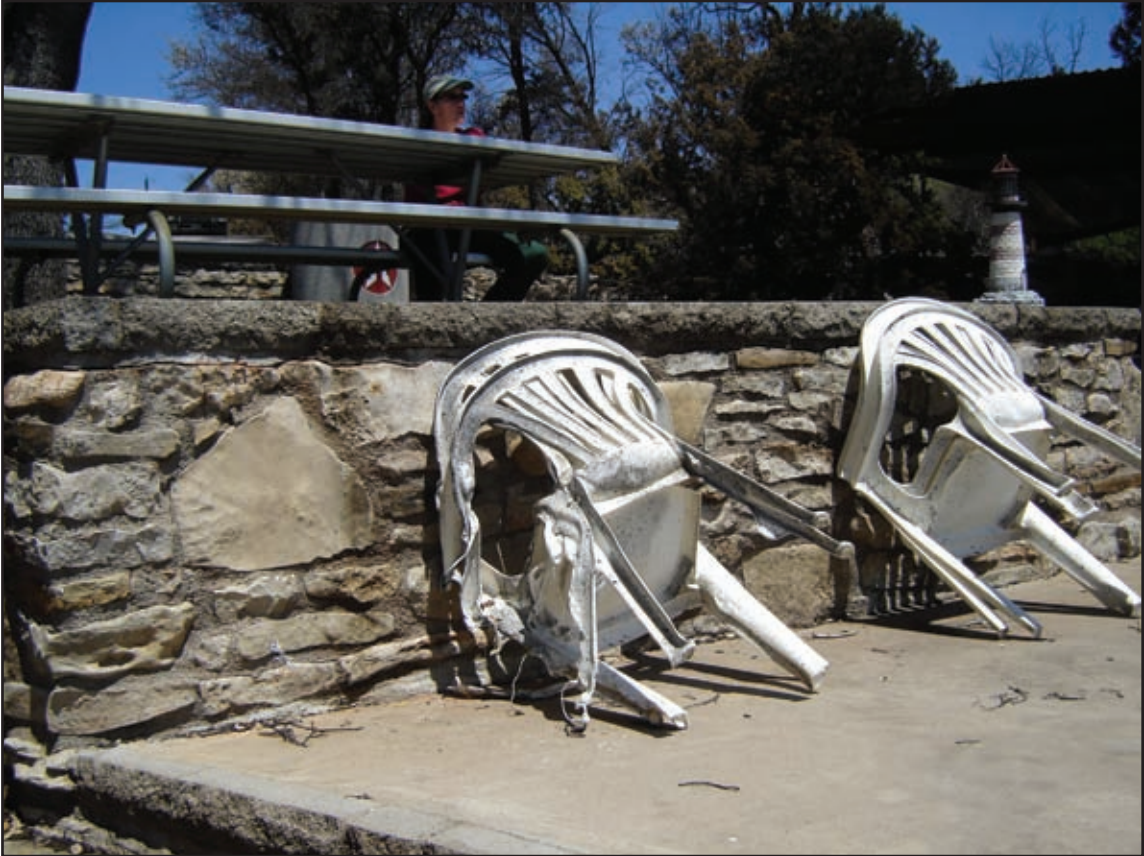
Next, the fire traveled half-a-mile to the opposite side of the inlet through a mixed evergreen-deciduous closed tree canopy of juniper and oak where eight homes located along the shoreline were lost. Four homes on Edgewater Lane were the first impacted by the approaching fire. A single-wide mobile home located at the top of a plateau surrounded by oaks and heavy cedar was the first to be destroyed. A cinder block foundation allowed for blowing embers to move under the foundation. Most mobile homes are up on block foundations, some with decks, and the majority of them are hooked up to gas, electricity and other utilities. As officials examine the need for building regulations for traditional, single-family homes, stronger mobile home regulations should be addressed as well in regard to Firewise construction.

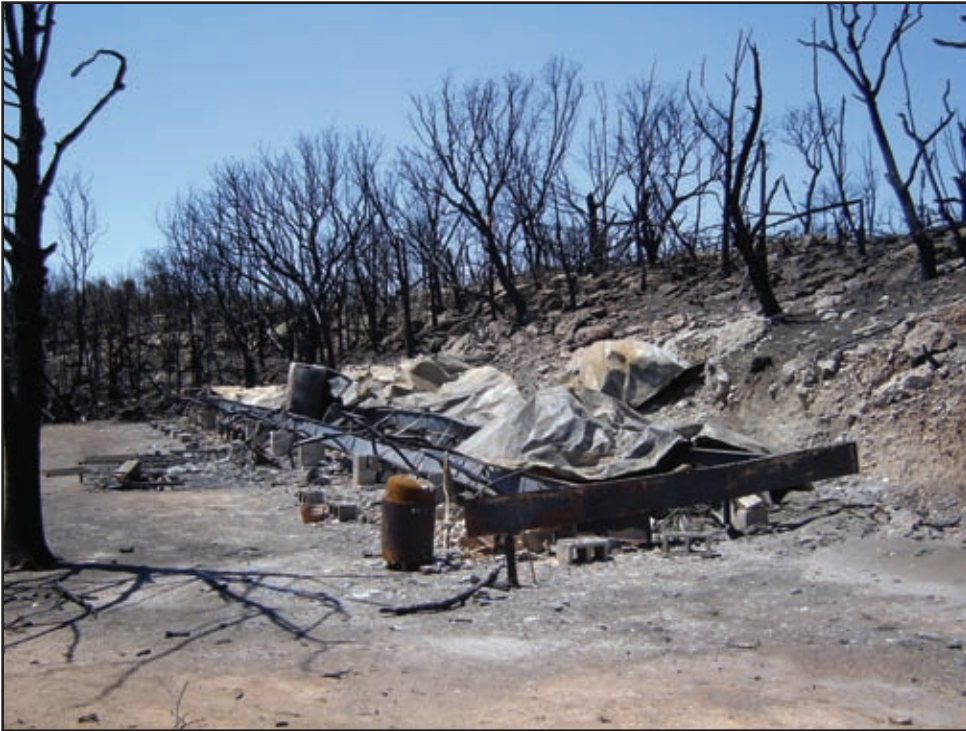
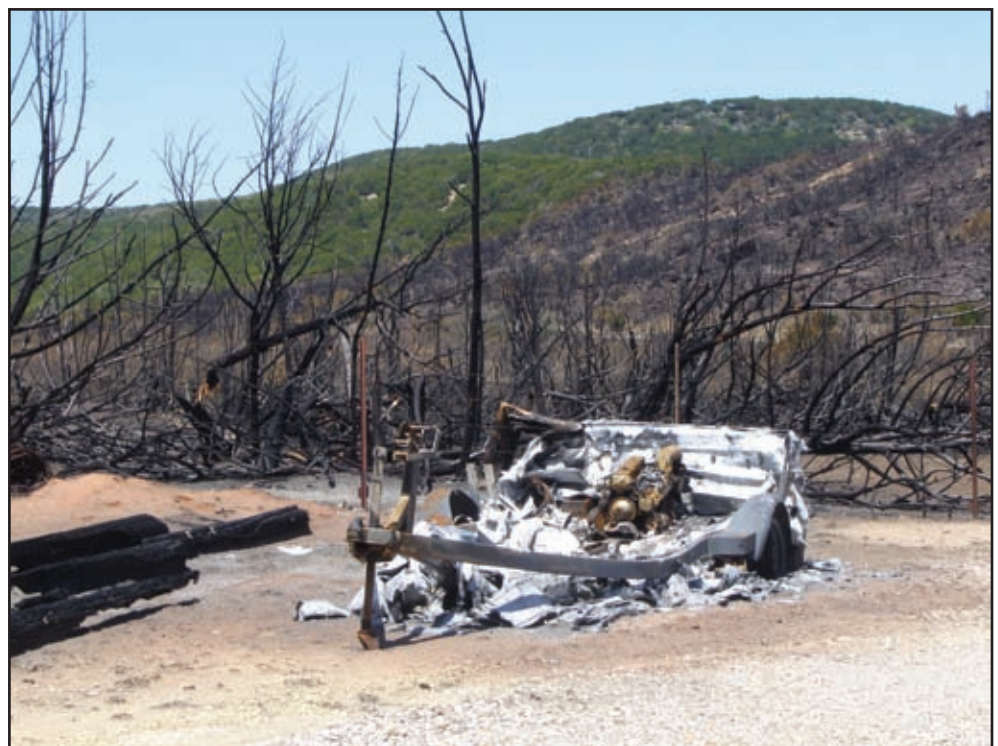
The next three structures — two masonry homes and one mobile home — were spaced 50 feet apart from one another. Spotting was evident by the unburned grass around the burned riding mower and unburned areas between burned homes. The wooden pier down to the dock was completely gone except for metal support poles. The proximity of cedar and oak along the slope down to the water edge was credited with enabling the heat to impact the structures.

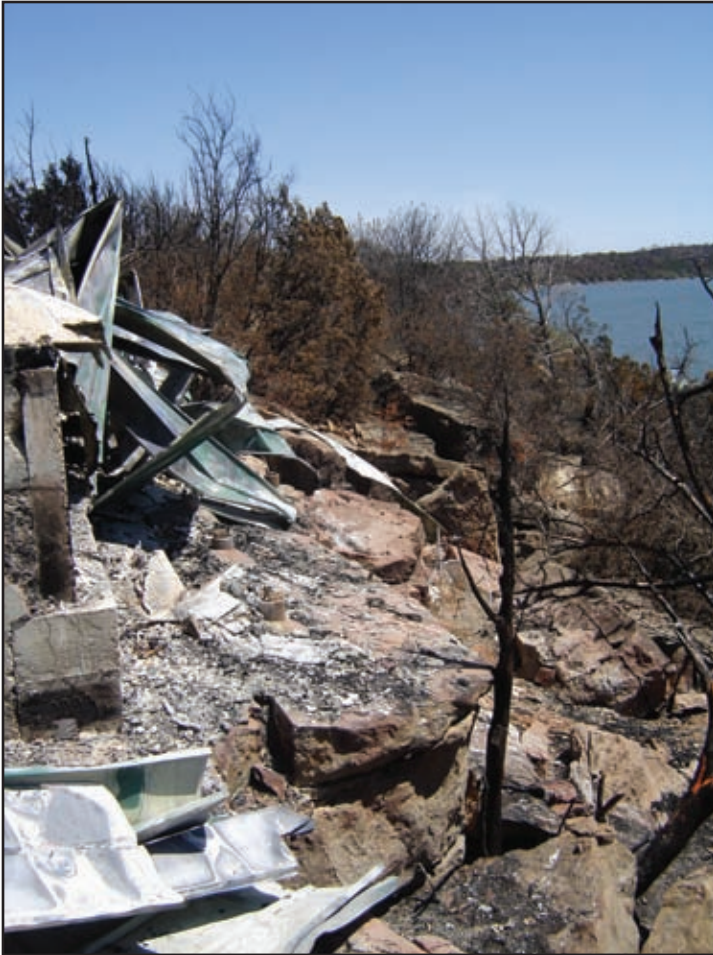
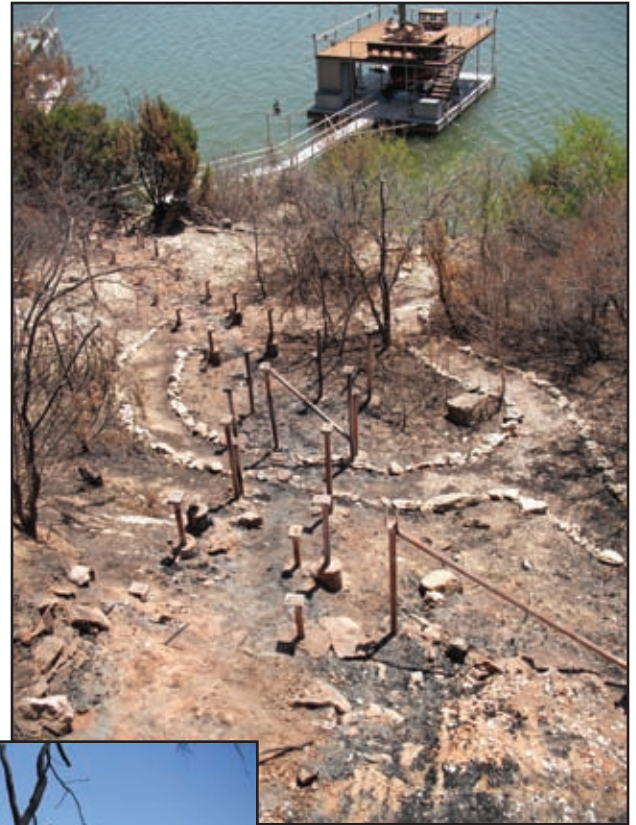
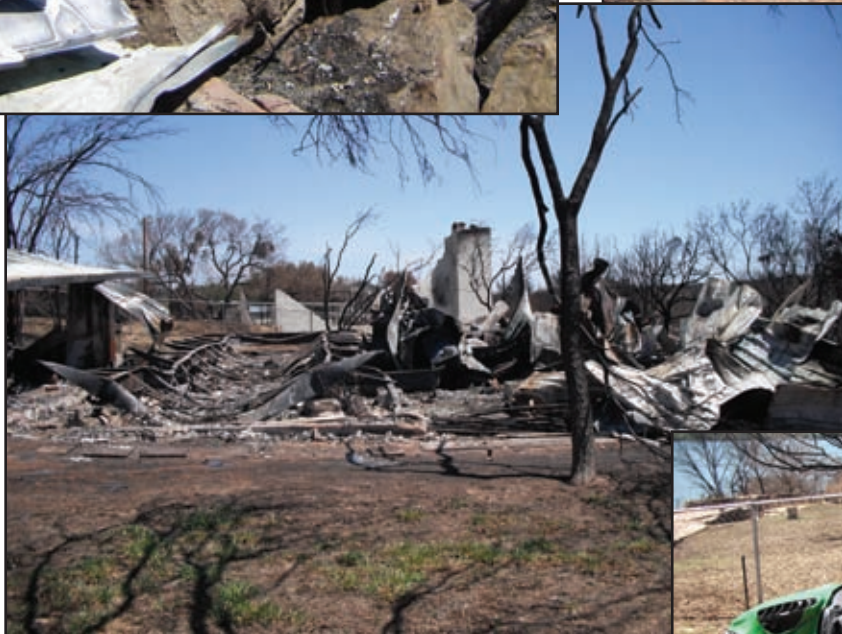
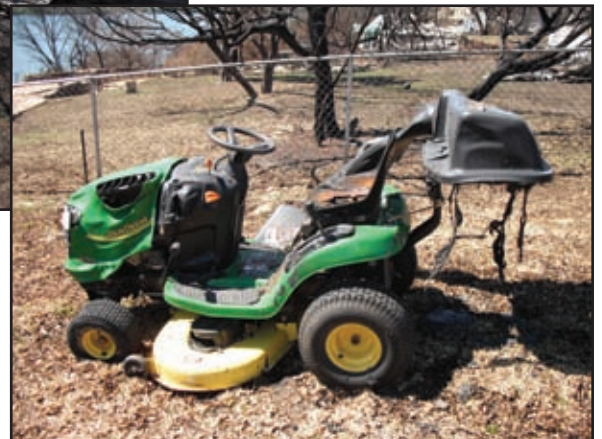
Another four homes lost were lost farther down the shoreline. Three of the homes were of brick construction and one was a mobile home. James Maddox, one of the residents, shared pictures of his home prior to the fire. He said that his family was out of town during the wildfire. Points of ignition on their home were: 1) cedar siding on the sun room on the east side of the home and 2) plastic eave material designed to reduce the need for painting and maintenance on the west side of the home that had melted off exposing the support beams. The short distance between cedars and the open carport contributed to the ignition of a boat and lawn equipment.

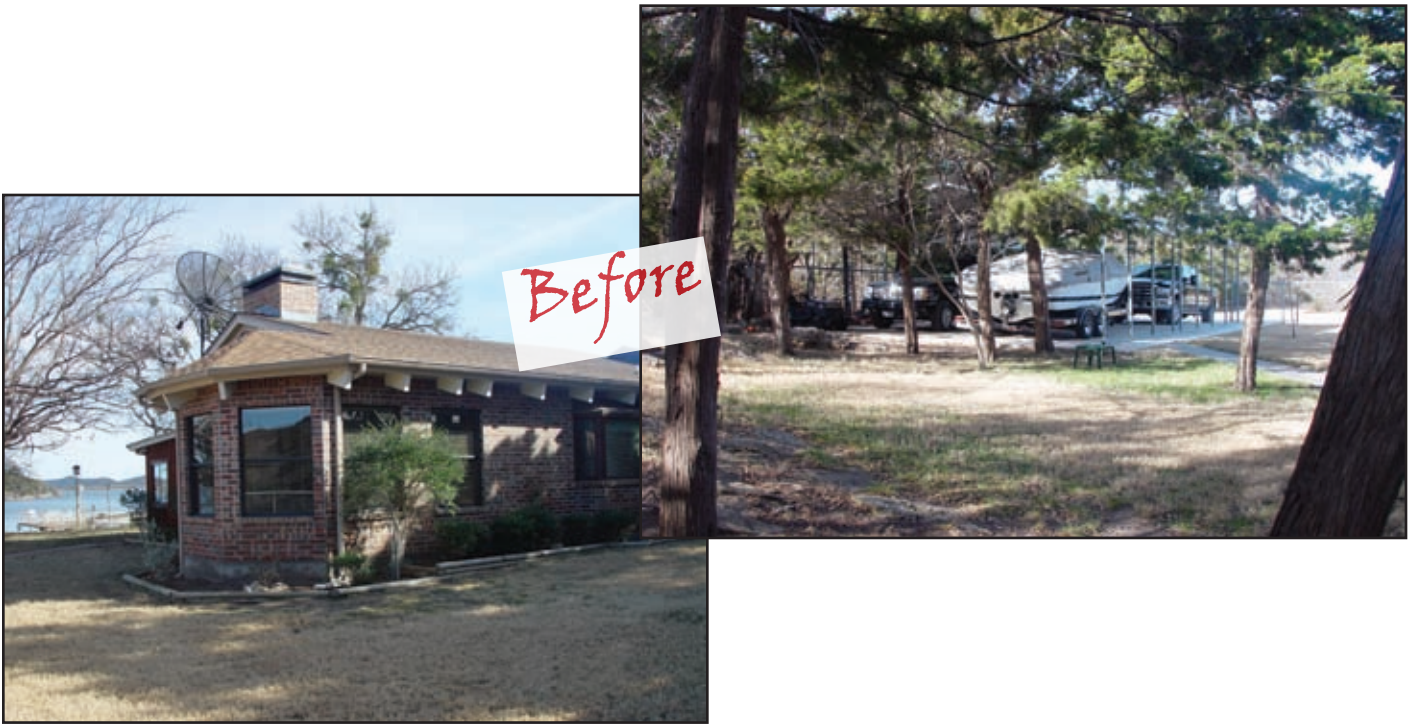
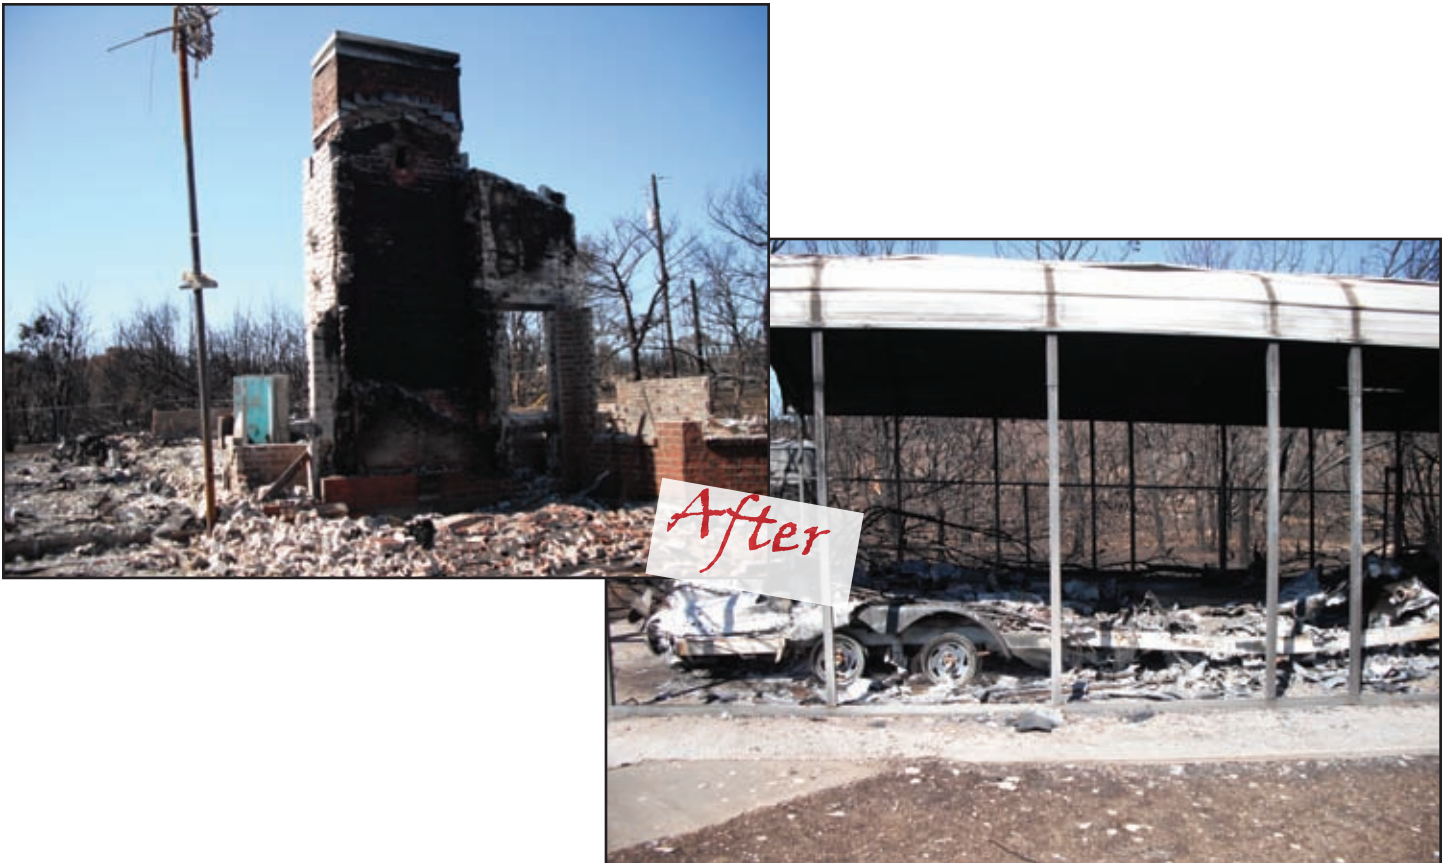
The fire spotted over the one-fourth of a mile-wide cove and ignited vegetation on the opposite side of the cove. This spotting resulted in the destruction of two more homes. The fire burned 296 acres where the Lone Camp Volunteer Fire Department spent 168 man-hours of suppression work saving multiple structures on the inlet where the fire was finally contained.

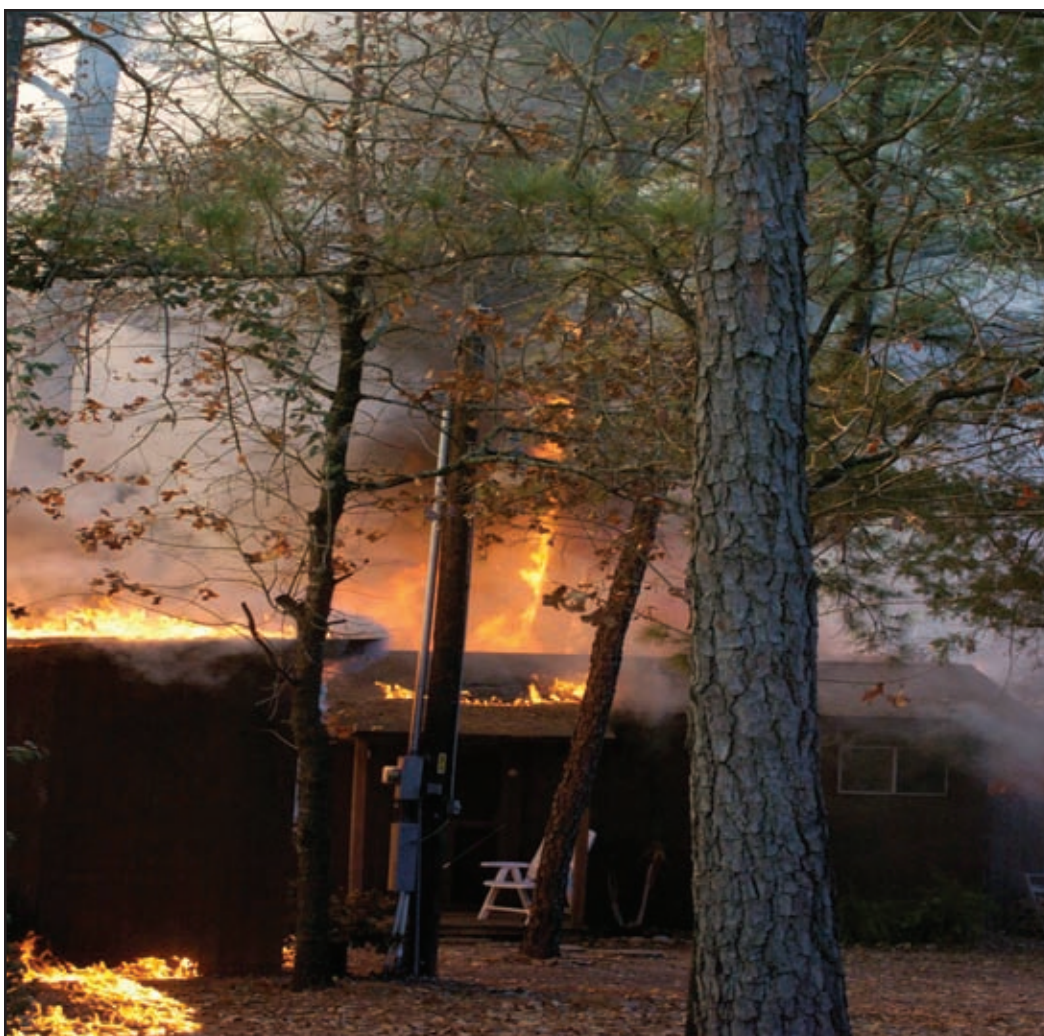
Embers start a fire on the roof while there is still unburned leaf litter on the ground around the home.

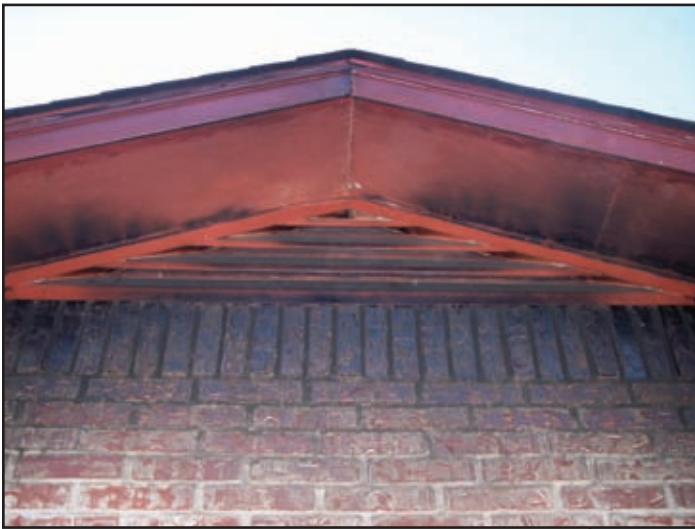
Grass embers entered through the gable vent on this house and ignited attic materials which resulted in the loss of the roof despite mitigation efforts by local volunteer fire departments.

Wind and/or direct contact with a fire’s convective heat can push firebrands through the vents into a home’s basement or crawlspace. Vent openings should be screened to prevent firebrands or other objects larger than one-fourth inch from entering the home. Both vents and screens should be constructed of materials that will not burn or melt when exposed to radiate or convective heat or firebrands. Also, these vents should be corrosion-resistant to help minimize maintenance.

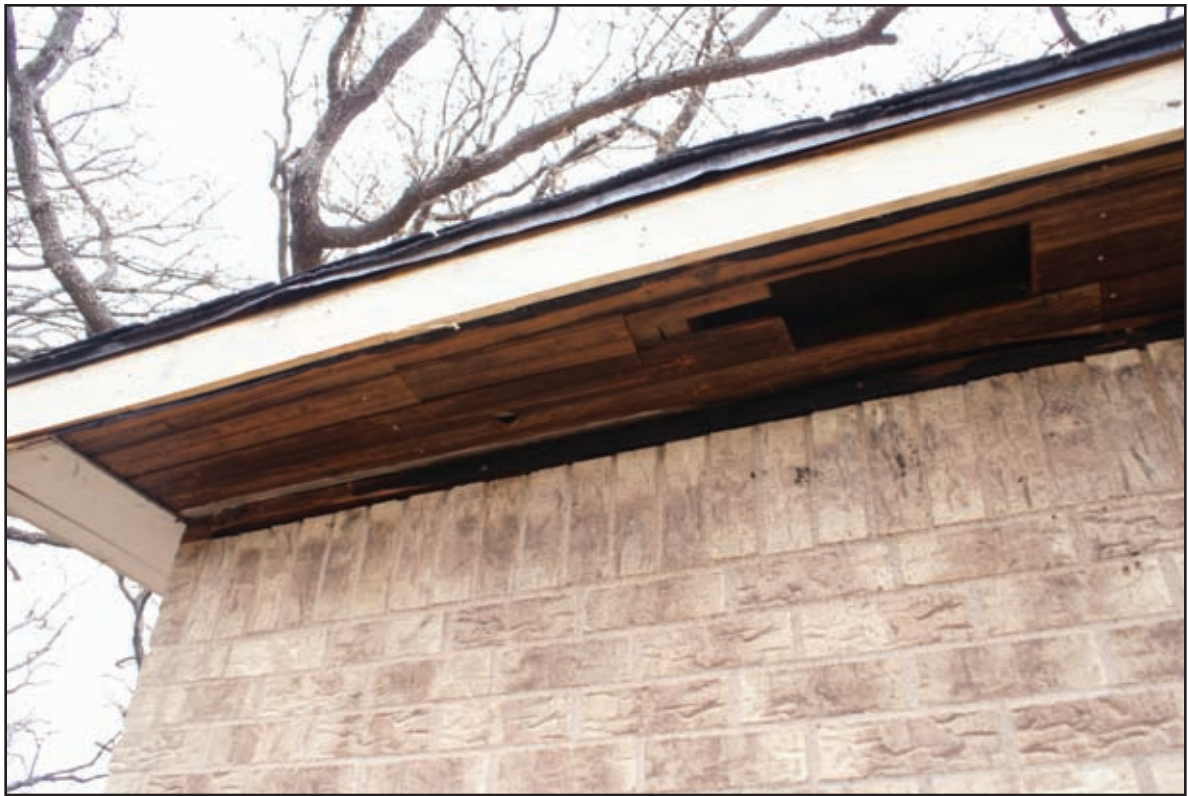
The homeowner witnessed embers blowing under the eaves and flames climbing the side of the house. Hours were spent putting out spot fires in the attic in order to save the house.

Eaves, fascias and soffits are vulnerable to both firebrands and convective exposures. They should be “boxed” or enclosed with noncombustible materials to reduce the size of the vents. Materials that melt or burn in relatively low temperatures, such as polyvinyl chloride (PVC) and vinyl siding should not be used, since they do not provide adequate protection and can melt in the heat of the wildfire. Non-combustible screening should be used in the vents. The current Texas building codes require a one-fourth inch mesh on vents which is the baseline regulation issued by the International Building Code (IBC) a model building code developed by the International Code Council (ICC). It has been adopted throughout most of the United States.

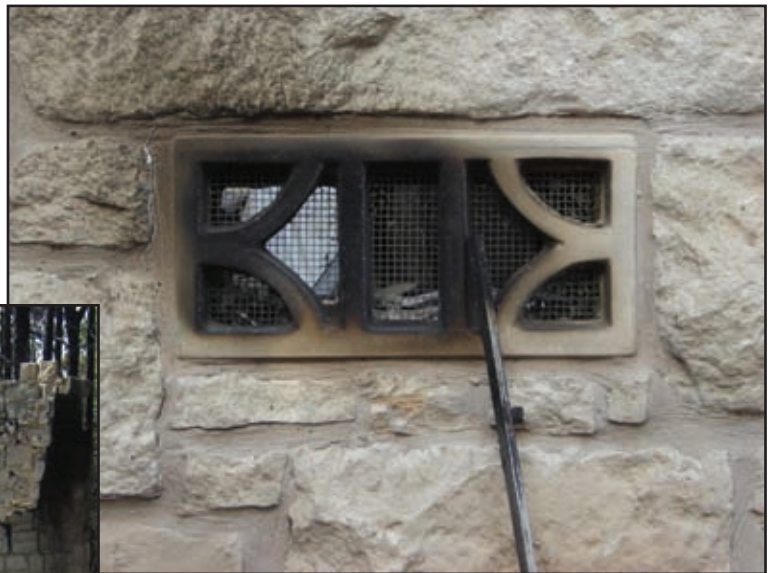
Despite the masonry construction, foundation vents allowed the entry of embers and flames into the home.
