## Hurricane Ike Tree Mitigation Plan

BROADWAY BOULEVARD  
(State Highway 87)

Galveston, Texas

October 2008

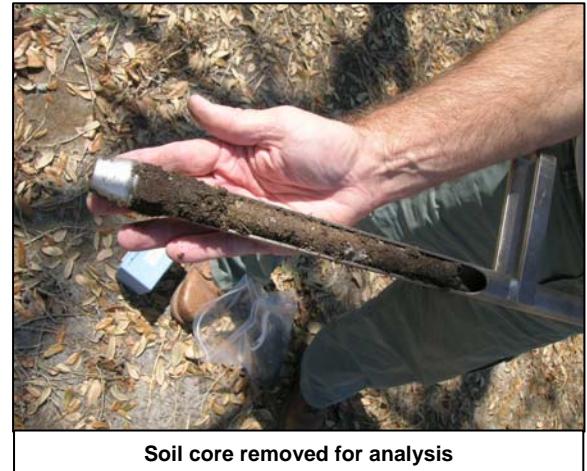
To test soil properties, TFS pulled four to five soil cores (12-16” deep, totaling approximately one cup) from every fifth median, for a total of ten samples over the 53 separate medians. In addition, we took one sample from a right-of-way and another sample (S-11) tested soil from just the upper 3” of median soil. These 11 samples were analyzed by A&L Analytical Laboratories, Inc., of Memphis, TN, for texture, pH, organic matter, nutrients, and the sodium (**Na**) level. Results are summarized in **Table 1** and the complete sample reports are included with this report.

Several key findings inform our recommendations. As we suspected, most of the samples showed high sodium levels, meaning a treatment plan is warranted. Sample S-11 showed the highest sodium value (4,886 lbs./acre), meaning that the highest levels of salt are still near the surface.
